**PREVENTING DAMAGE
TO SWIMMING POOLS**

**SGS INTRON
BULLETIN**

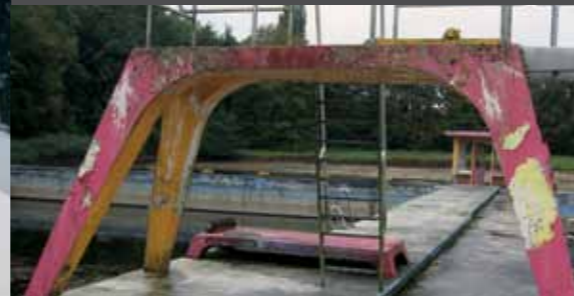
The result is impressive. The restored complex has been made beautiful again. The piers and the characteristic starting blocks and diving towers have been restored (see photo). Since summer 2011, the pool has again been used for swimming, just like in the good old days!

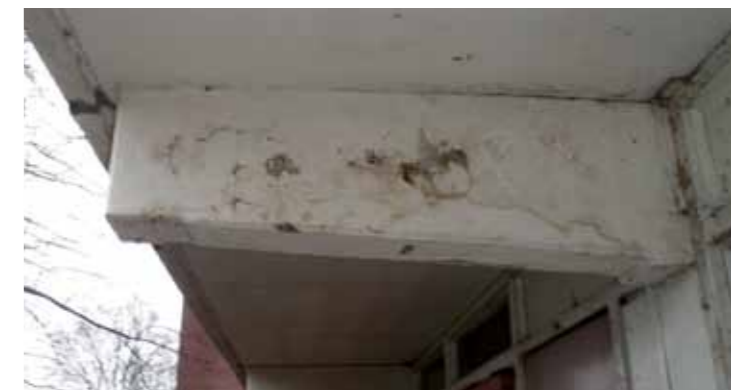
Brackets in which cracks were found during the visual inspection.

In his presentation "Five steps to a trustworthy galley flat" Martin Jonker explained how potential problems are identified via a risk analysis and how they can be handled. His colleague Maarten Swinkels explained what damage can occur and how this can be recognised. To conclude, Theodoor Gijsbers detailed the possibilities in the area of non-destructive testing: "SGS INTRON has a whole range of advanced techniques such as radar and eddy current tests designed to investigate concrete and reinforcement without damaging the structure. This is a strong point as - combined with minimal and highly selective destructive testing - we can reliably map the entire structure."

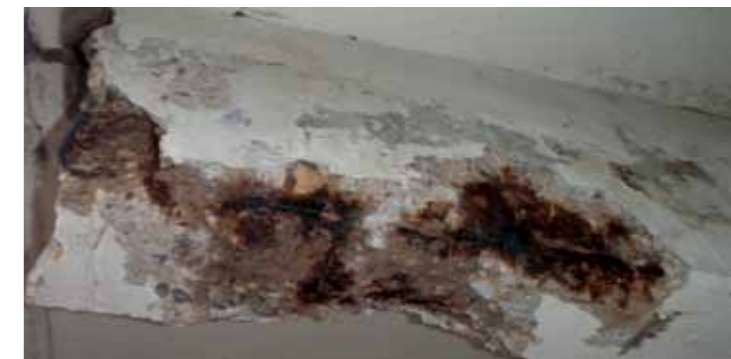
Serious reinforcing corrosion (initial chloride) found by destructive testing.
